**NASA  
Technical  
Paper  
2143**

1983

# Service Life Evaluation of Rigid Explosive Transfer Lines

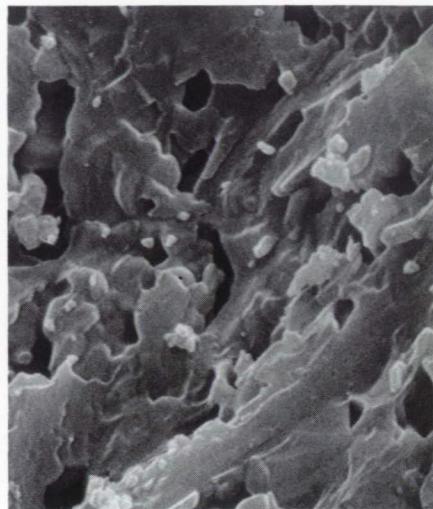
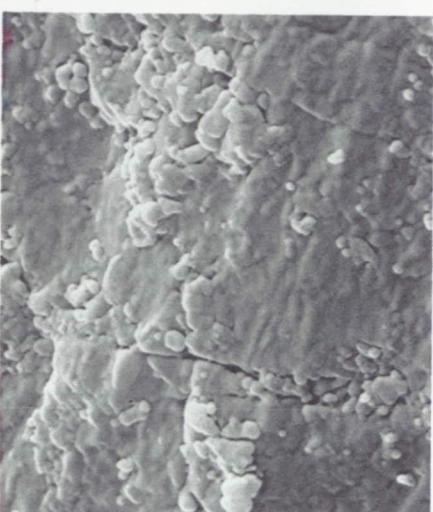
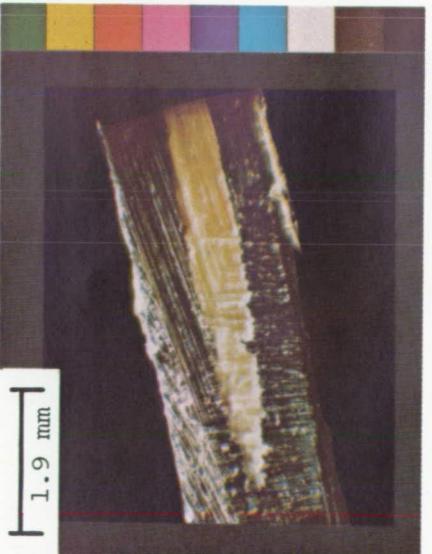
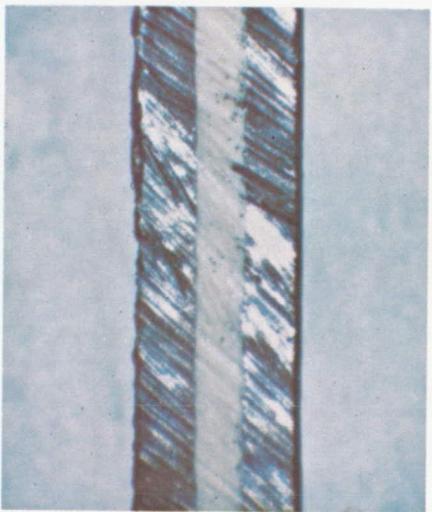
Figures 9(a) and 10(a) show the only "new" explosive samples. The AH-1S transfer lines were the only samples that were recently manufactured and had no flight service. However, no appreciable color or SEM differences were observed in the AH-1S or AH-1G service or repeat thermal qualification samples, as shown in figures 9 through 14.

(a) 99.8% (by wt) HNS-I/HNBiB;  
no service;  
3 years total age.

(b) 98.0% (by wt) HNS-I/HNBiB;  
4.7 years total service;  
5.1 years total age.

(c) 93.7% (by wt) HNS-I/HNBiB;  
no service;  
3 years total age;  
400°F for 50 hr. L-83-39

Figure 9.— Macrophotographs (upper row) and scanning electron micrographs (lower row) of typical samples of AH-1S booster tip explosive.

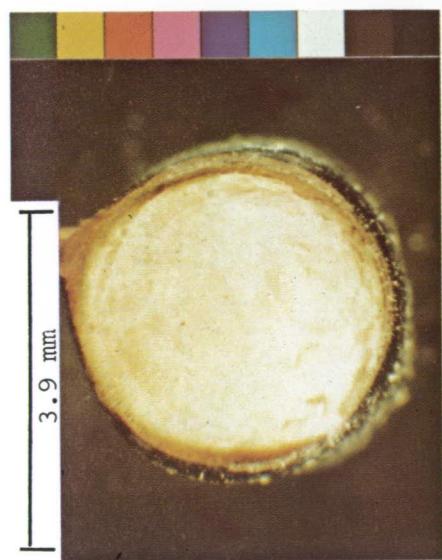
(a) 97.0% (by wt) HNS-II/HNBiB;  
no service;  
3 years total age.

(b) 99.8% (by wt) HNS-II/HNBiB;  
4.7 years total service;  
5.1 years total age.

(c) 88.1% (by wt) HNS-II/HNBiB;  
no service;  
3 years total age;  
400°F for 50 hr.

Figure 10.— Macrophotographs (upper row) and scanning electron micrographs (lower row) of typical samples of AH-1S transfer line explosive.

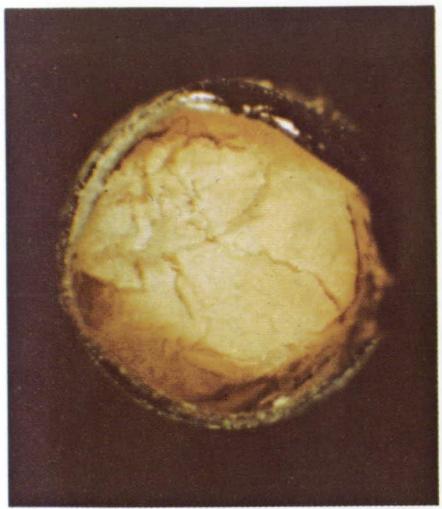
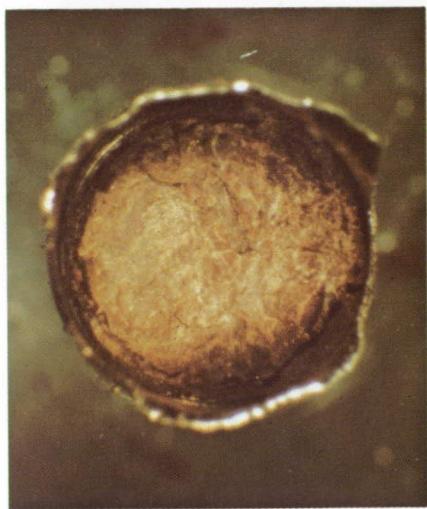
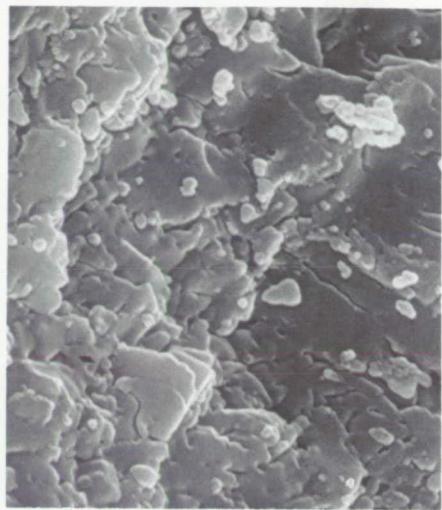
As heat-induced degradation occurred in the AH-1G HNS explosives, both the color and physical texture of the explosives changed, as shown in figures 11 through 14. The booster tip explosive gradually darkened from the outer circumference inward (fig. 15). The SEM's (figs. 12 and 14) indicate a gradual roughening of the particles as degradation increases, to a perforated "Swiss cheese" texture, where the explosive becomes nonfunctional. Figures 15 and 16 provide further examples of degradation. Careful removal and analysis of the darkened outer explosive in figure 15 revealed considerably more degradation than in the central material. In figure 16, the darkest colors and color gradation correspond with highest density at the major diameter, and the lightest colors correspond with the lowest density at the smallest diameter. These density variations are induced by pressing the explosive into a conical cavity.

(a) 98.6% (by wt) HNS-I/HNBiB.

(b) 95.7% (by wt) HNS-I/HNBiB; repeat thermal qualification (200°F for 72 hr.).

(c) 98.3% (by wt) HNS-I/HNBiB; 375°F for 50 hr.

(d) 94.3% (by wt) HNS-I/HNBiB; 400°F for 50 hr.

(e) 91.8% (by wt) HNS-I/HNBiB; 425°F for 50 hr.

Figure 11.— Macrophotographs of typical samples of AH-1G booster tip explosive. All lines have 5 to 7 years total service and are 8 years old.

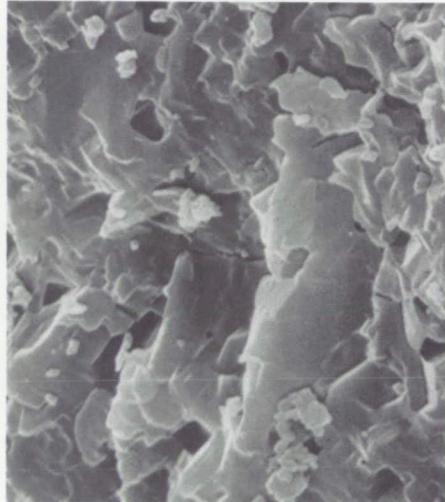
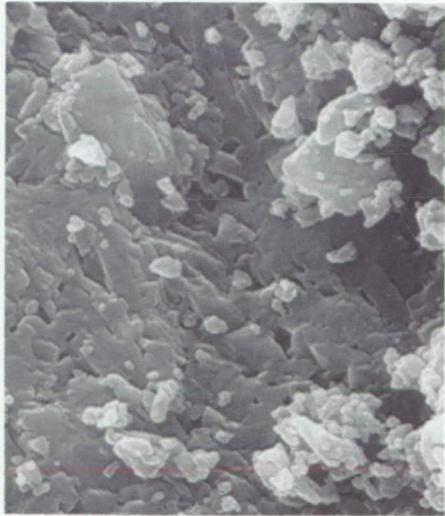
(a) 98.6% (by wt) HNS-I/HNBiB.

(b) 95.7% (by wt) HNS-I/HNBiB; repeat thermal qualification (200°F for 72 hr.).

(c) 98.3% (by wt) HNS-I/HNBiB; 375°F for 50 hr.

Figure 12.— Scanning electron micrographs of typical samples of AH-1G booster tip explosive. All lines have 5 to 7 years total service and are 8 years old.

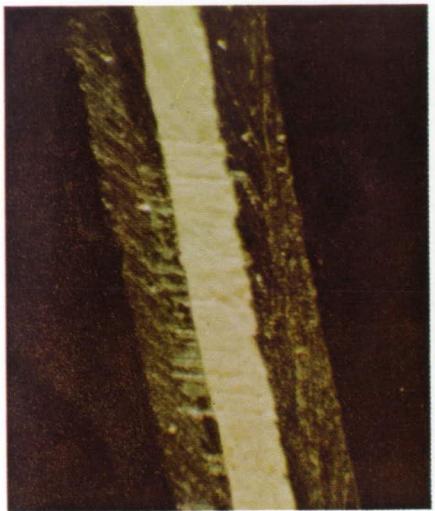
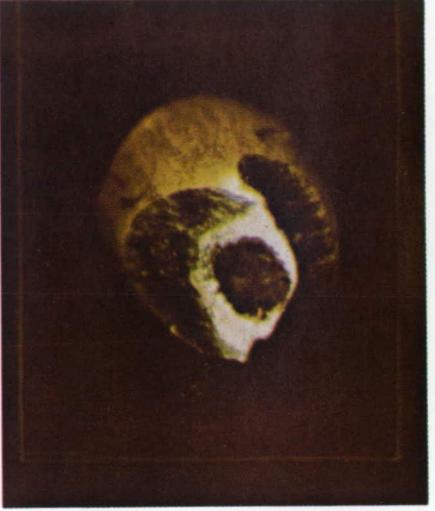
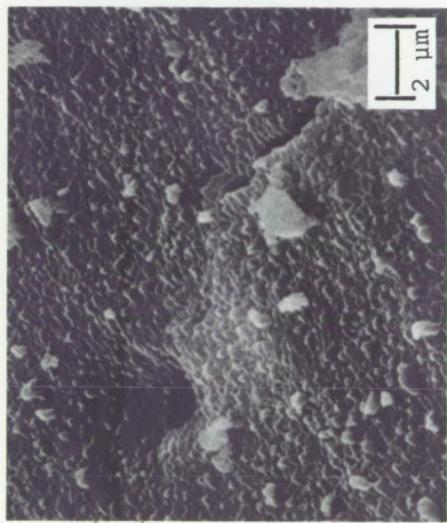
(a) 97.1% (by wt) HNS-II/HNBiB.

(b) 94.5% (by wt) HNS-II/HNBiB;  
repeat thermal qualification  
(200°F for 72 hr.).

(c) 98.0% (by wt) HNS-II/HNBiB;  
375°F for 50 hr.

(d) 82.2% (by wt) HNS-II/HNBiB;  
400°F for 50 hr.

(e) 21.7% (by wt) HNS-II/HNBiB;  
425°F for 50 hr.

Figure 13.- Macrophotographs of typical samples of AH-1G transfer line explosive. All lines have 5 to 7 years total service and are 8 years old. L-83-43

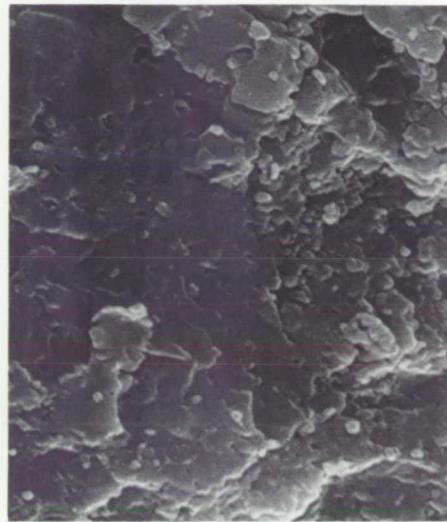
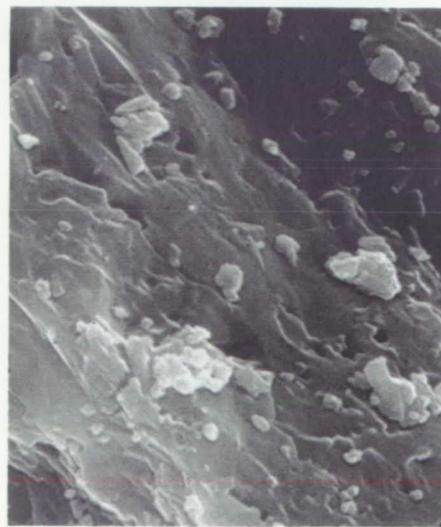
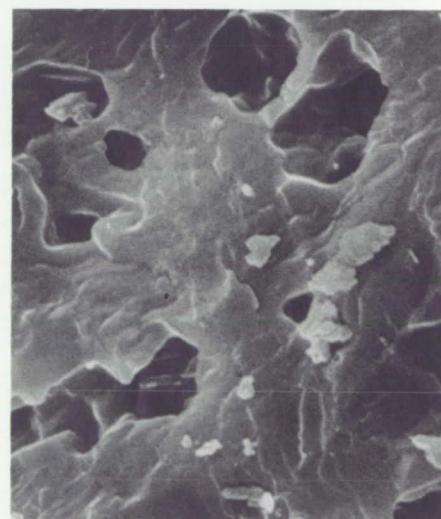
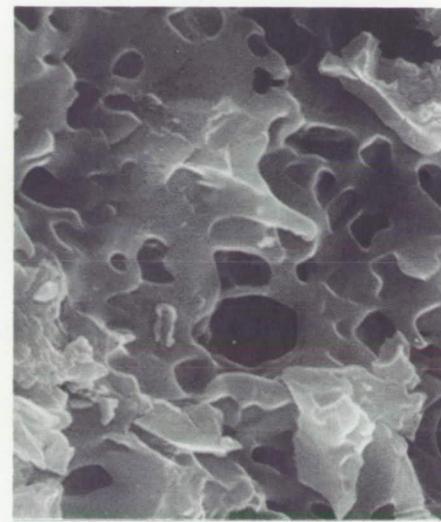
(a) 97.1% (by wt) HNS-II/HNBiB.

(b) 94.5% (by wt) HNS-II/HNBiB;  
repeat thermal qualification  
(200°F for 72 hr).

(c) 98.0% (by wt) HNS-II/HNBiB;  
375°F for 50 hr.

(d) 82.2% (by wt) HNS-II/HNBiB;  
400°F for 50 hr.

(e) 21.7% (by wt) HNS-II/HNBiB;  
425°F for 50 hr.

Figure 14.— Scanning electron micrographs of typical samples of AH-1G transfer line explosive. All lines have 5 to 7 years total service and are 8 years old.

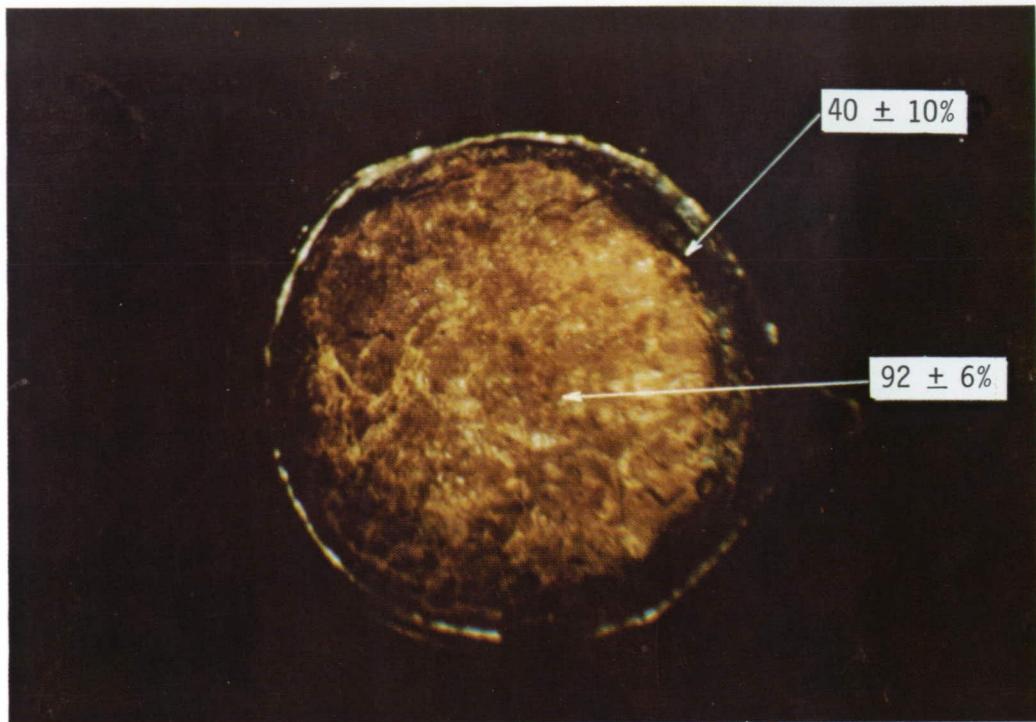
Figure 16.- Side view of ferrule charge removed from a transfer line exposed to 425°F for 50 hr.

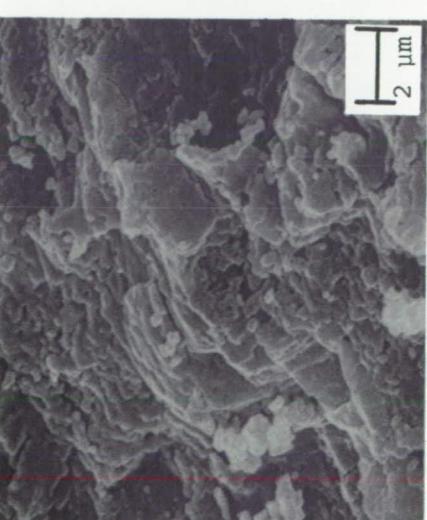
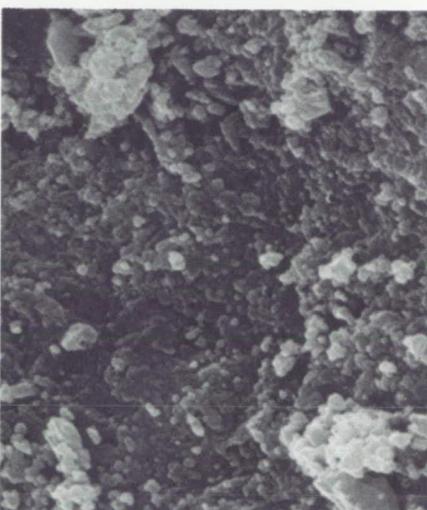
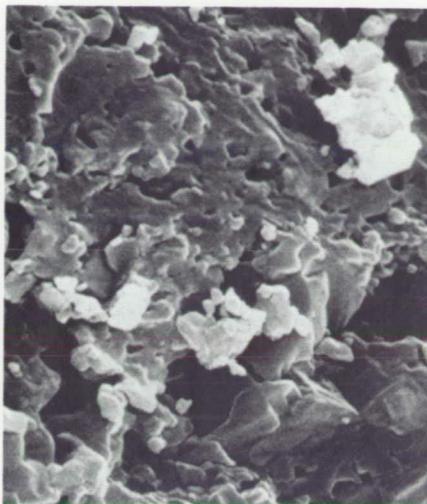
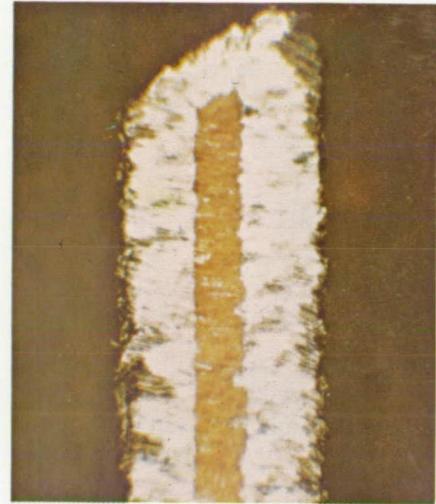
Figures 18 through 20 highlight the test extremes for the F-14, B-1, and F-111 transfer lines, respectively. No changes were observed with service and age. For the F-14 lines, the 425°F, 50-hr sample was nonfunctional. Although some change was detected for the B-1 lines after exposure to 425°F for 50 hr, all lines remained functional. No changes in color or physical appearance were detected for the F-111 DIPAM lines after exposure to 450°F for 50 hr (fig. 20). Total decomposition occurred in a 500°F, 50-hr exposure.

(a) 100% (by wt) HNS-II/HNBiB;  
6.5 years total age.  
(b) 99.9% (by wt) HNS-II/HNBiB;  
9 years total age.  
(c) 56.3% (by wt) HNS-II/HNBiB;  
6.5 years total age;  
425°F for 50 hr.

L-83-48  
Figure 18.- Macrophotographs (upper row) and scanning electron micrographs (lower row) of typical samples of F-14 transfer line explosive. All lines have 3 years total service.

(a) 97.0% (by wt) HNS-II/HNBiB;  
3 years service;  
3.5 years total age.

(b) 95.7% (by wt) HNS-II/HNBiB;  
no service;  
7 years total age.

(c) 88.35% (by wt) HNS-II/HNBiB;  
3 years service;  
3.5 years total age;  
425°F for 50 hr.

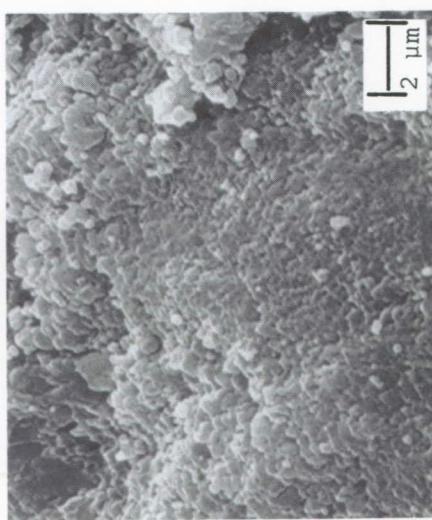
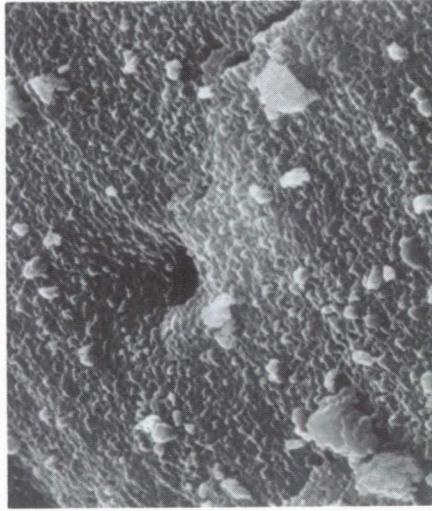
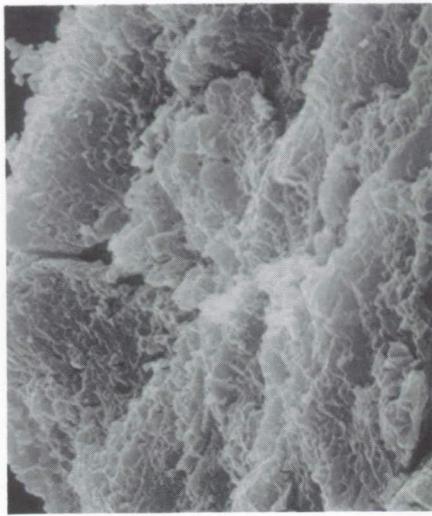
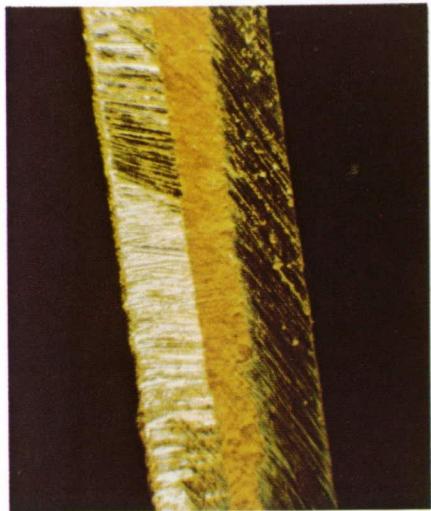
L-83-49  
Figure 19.- Macrophotographs (upper row) and scanning electron micrographs (lower row) of typical samples of B-1 transfer line explosive.

(a) 100.9% (by wt) DIPAM;  
5.5 years total age.
